CARLO GAVAZZI

Sx Tool Download

Tips & Tricks

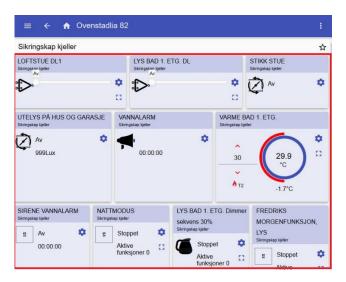
Wrong icons shown in the web App

After a firmware upgrade of the system the icons in the web App are not correct (the icons are messed up or missing).

The error is due to the cache of the web browser, the issue will be resolved cleaning the cache and logging-in again in the web App.

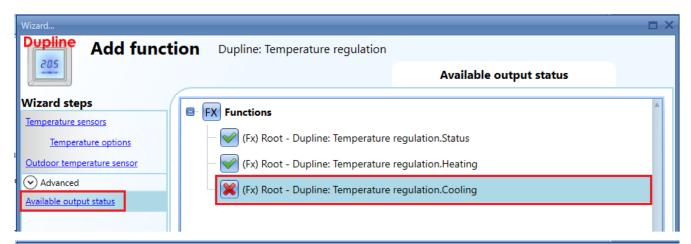
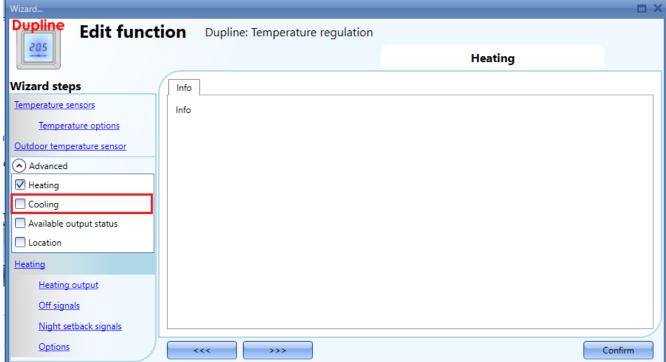
Dupline temperature regulation function deactivates the heating setpoint

When the advanced field Cooling is selected in the Dupline temperature regulation and there is no output signal used, the temperature function activates the cooling set point every time the configuration file is sent to the controller, consequently the heating function goes from heating T1 to TOFF and stops heating.

This problem happens also when the controller restarts because the system loads the configuration at startup and the cooling setpoint is activated.

In the advanced menu "available output status" the signal temperature regulation. Cooling should be deactivated.

The advanced menu "Cooling" should be unselected.

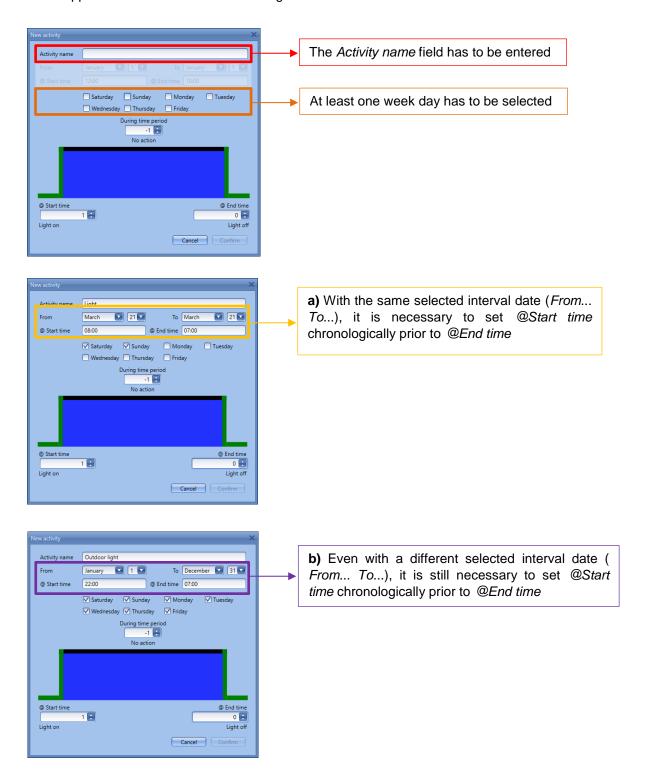
Calendar activities cannot be added

When a calendar activity is going to be added either in the *Local calendar* of the functions where it is available in the *Advanced* options, or in the *Global calendar* function, after filling the required fields the *Confirm* button cannot be pressed (this is shown in grey colour).

This happens if at least one of the following conditions is verified:
